Manhole Inspection Summary

Manhole # S17EE2012MH

Insp Date: **8/3/06 9:00 AM**

Location Address: **1900 SULGRAVE AVE**

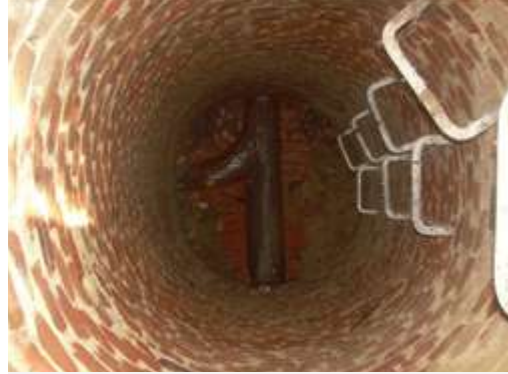
Top View

Barrel infiltration. Evidence of surcharge - Bench debris.

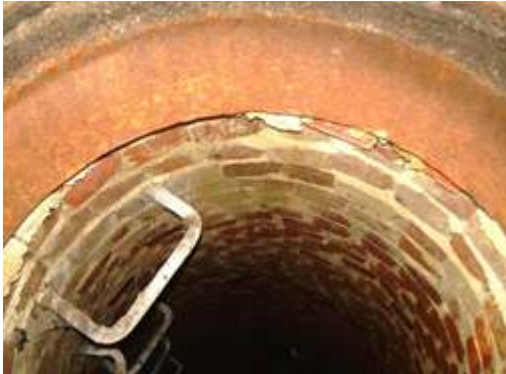
Defect

Frame leaks. Frame offset. Adjustment deterioration, loose brick and infiltration. Corbel infiltration - other side.

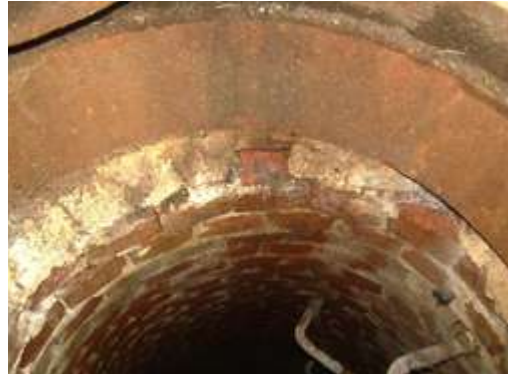
Defect

Frame leaks. Frame offset. Adjustment deterioration, loose brick and infiltration. Corbel infiltration.

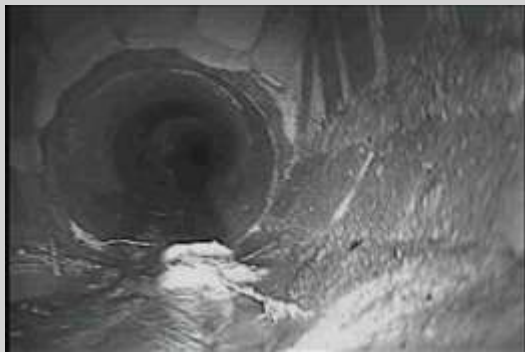
8 in. Circular Gravity Sewer Pipe Out @ 12 O'Clock

Infiltration: **Evidence** Pipe Seal Cond: **Unknown**

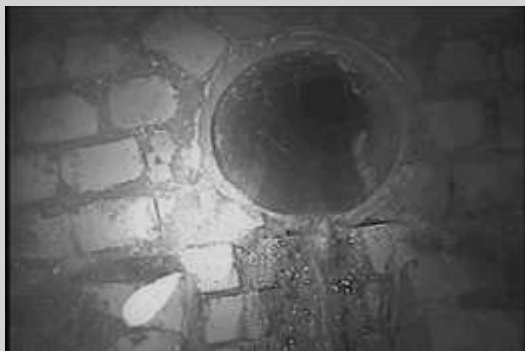
8 in. Circular Gravity Sewer Pipe In @ 6 O'Clock

Infiltration: **Evidence** Pipe Seal Cond: **Unknown**
